# An Update on the Hydrogeology of Magdalena, Socorro County, New Mexico

Open-file Report 556

August 2013

Stacy S. Timmons

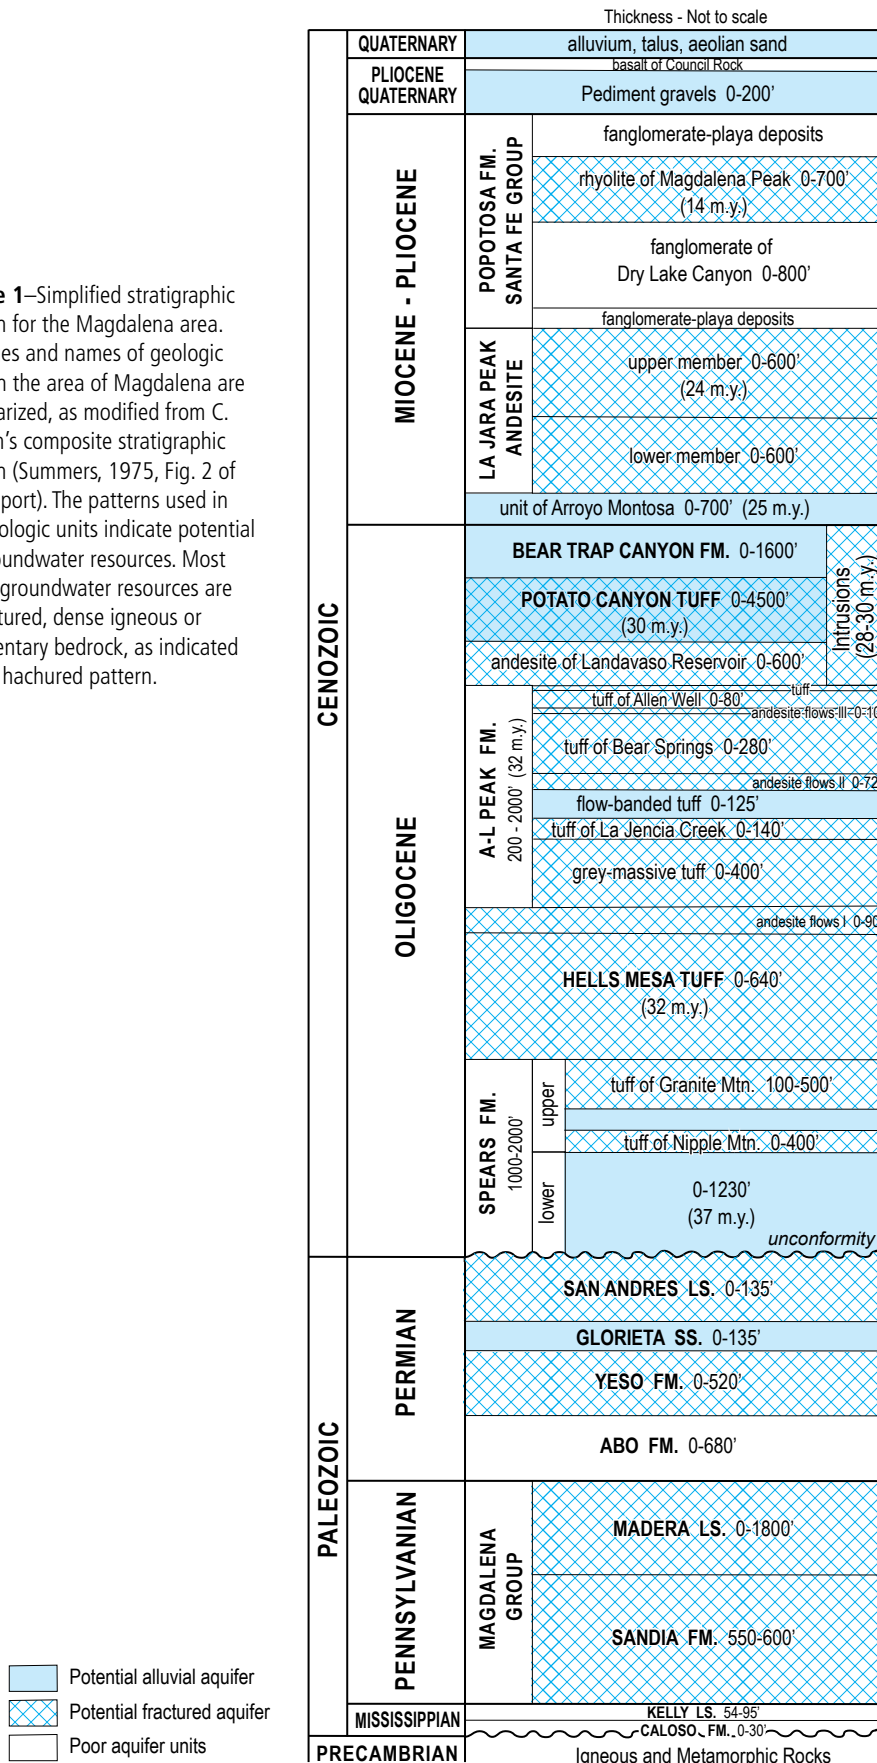
**Figure 1**—Simplified stratigraphic column for the Magdalena area. The ages and names of geologic units in the area of Magdalena are summarized, as modified from C. Chapin's composite stratigraphic column (Summers, 1975, Fig. 2 of that report). The patterns used in the geologic units indicate potential for groundwater resources. Most of the groundwater resources are in fractured, dense igneous or sedimentary bedrock, as indicated by the hachured pattern.

The geology of the region is complex, with geologic units ranging from Precambrian granite and metamorphic-sedimentary units, to Paleozoic sedimentary rocks, with Oligocene to Pliocene igneous rocks, covered in places with deposits of Cenozoic alluvial units (Fig. 1). The sedimentary rocks observed in this study include Pennsylvanian and Permian age units of the Madera, Abo, Yeso, and San Andres Formations. Many of the tuffs and volcanic flows from the Oligocene, Miocene and Pliocene eruptions are dense and form fairly low porosity, low permeability units that are highly fractured. Additional sedimentary units (composed of re-worked volcanic rocks) exist locally between volcanic deposits, deposited during volcanically inactive periods. The region in and around Magdalena has been further complicated by extensive faulting and fracturing, with additional intrusions of igneous dikes and sills in many locations.

In this region of New Mexico, groundwater is typically found within 1) fractured/faulted bedrock aquifers and 2) alluvial aquifers. The fractured bedrock aquifers hold water within the cracks (fractures) of the rock. Fractured aquifers generally have little stored water within the rock itself, as it has little pore space (low porosity), but these aquifers can transmit water quickly through fractures. In the Magdalena area, these aquifers are typically in crystalline bedrock such as granite or metamorphic rocks, dense volcanic material (i.e. densely welded tuff, andesite flows), or carbonates (i.e. limestone) (Fig. 1).
